# Building and Rebuilding Agricultural Terraces in the Colca Valley of Peru<sup>1</sup>

John M. Treacy

This article reviews some technical and political aspects of terracing based upon observation of a project to rehabilitate 30 hectares of abandoned terraces in the village of Coporaque in the Colca Valley, Department of Arequipa, Peru (Figure 1). The Coporaque project is unfinished and the analysis here is preliminary. The point of departure is a brief background discussion of terracing in the valley, followed by a description of terrace construction and reconstruction. By observing a large-scale restoration effort, fieldwork employed ethnographic analogy to discover how pre-Hispanic terraces were made in the region. Colca Valley farmers themselves derive principles of terrace engineering by building or repairing them. Their teachers, they say, are the *machulas*, or ancestors, who built the walled fields that farmers today continue to plant and harvest. The closing section reflects on terrace research and its relationship with the politics of terrace restoration.

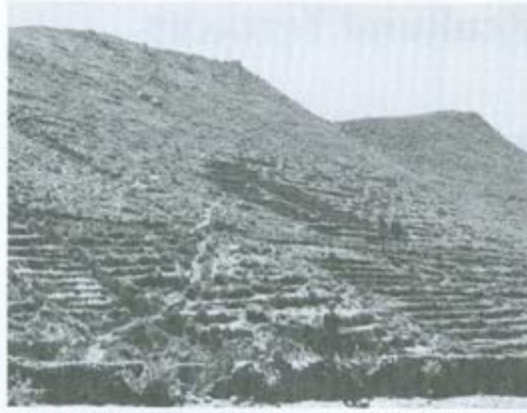
Fig. 2. Valley-side walled terraces. Cultivated terraces line the slope below a contour canal. Abandoned and semi-restored terraces are above.

The magnificently sculpted terrace landscape of the Colca Valley is a triumph of Andean engineering. The valley contains more than 14,000 hectares of fields (Denevan and Hartwig 1986, 104); two-thirds of them are walled, irrigated valley-side terraces (Figure 2); the rest are embanked, leveled bottomland fields on wide alluvial plains (Figure 3). Radiocarbon tests indicate that some of the fields may date from between 300 and 800 A.D. (Malpass 1986, 163-165); however, firm archaeological sequences for the region are lacking. Evidence of Inca occupation in the valley is widespread.

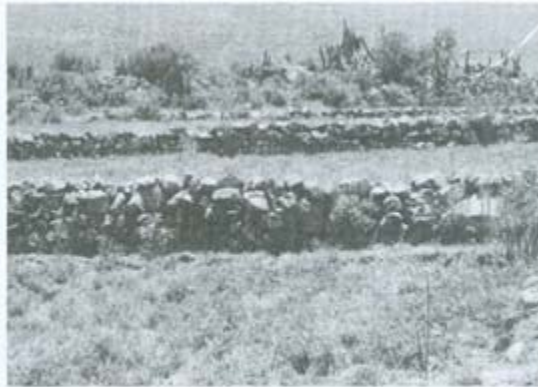
Fig. 3. Bottomland embanked terraces with alfalfa. The walls are 40 to 80 cm high.

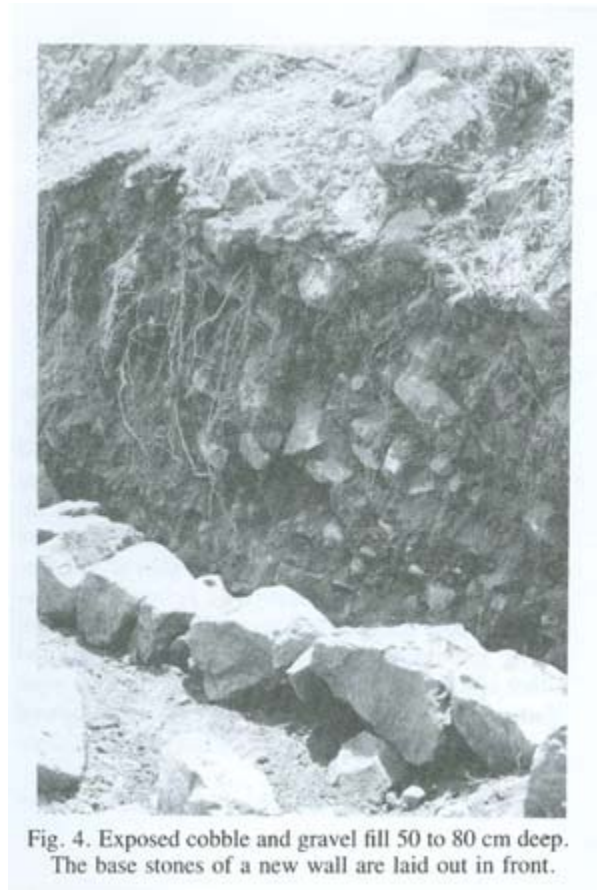
using gravity to help move soil behind the walls. The terrace base is comprised of stones placed upon bedrock or, more commonly, upon the hard subsoil some 50 cm deep. Behind the base builders placed a cobble and gravel fill layer from 50 to 80 cm deep (Figure 4). There are four probable explanations for the fill: (1) it was a dump for excess stone and gravel; (2) it economized on the amount of earthen fill required to level the terrace; (3) it lessened the weight of material behind the wall, thus reducing the risk of wall failure; (4) it provided quick drainage when the terrace became saturated. Farmers today cite drainage as the primary reason for the fill, however, all the above explanations are plausible.

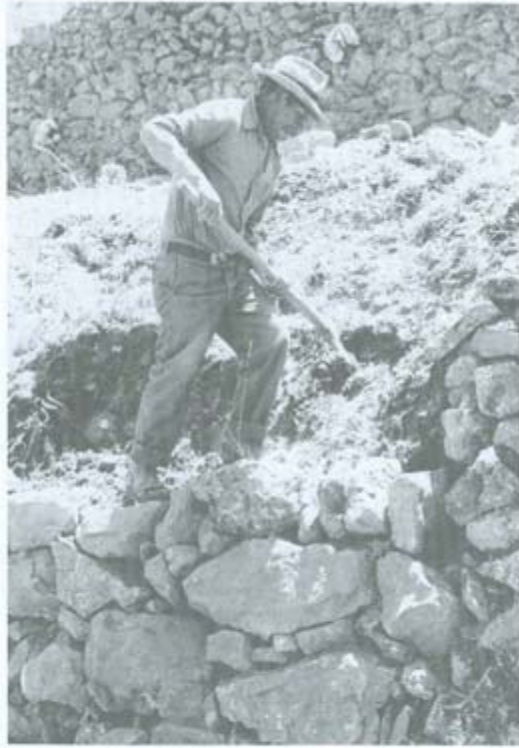
Fig. 5. Farmer standing upon half-completed wall, moving earth downward to fill in behind the stones. Note the jig-saw masonry style.

Leveling the terrace above the base and fill involved digging into the slope, moving soil down toward the wall, and packing it tightly while building the wall higher to retain the soil (Figure 5). As an irrigated terrace on a valley-side slope must be level, or nearly so, to economize on water, builders probably moved the soil themselves during construction, not waiting for natural erosion processes to fill the terrace slowly. In the Colca region, high, unirrigated, segmented terraces were self-filling, as were some of the less-sloping bottomland fields that lack artificial fills. Terrace walls feature indented vertical channels called *qhalchas* (Figure 7) and horizontal stone-embanked canals at the wall bases. These built-in devices indicate irrigation planning accompanied terrace construction. Terraces slope slightly forward or to one side to allow gravity flow of irrigation water over the platform. The degree of slope generally determines the height and width of terraces although variations in this relationship are common, probably because of differences in topsoil depth. On places where the original topsoil was thin, terraces are low and narrow. The average height of the restored Coporaque terraces is 1.6 m and average platform width is 4.9 m. Vertical columns of terraces are bounded by long vertical irrigation channels, and irrigation methods probably determined optimal terrace length. The restored terraces are 46 m long. Stone masonry style on original terraces follows no easily discernible pattern of rows nor displays stone size gradients from the base toward the top. Stones 40 cm in diameter often nestle upon stones 10 cm in diameter. Some farmers believe the reason for the jig-saw like masonry is that, during construction, groups of stonelayers worked rapidly, spread out along slopes, each working on segments of a terrace. By working independently, masons could not match up long rows of stones. Gap repairs of damaged terraces, however, do display row-by-row masonry, called *estaquillado* (Figure 6). Experienced wall builders point out that it is not size nor pattern but the idiosyncrasies of stone fit and balance that determine wall strength. Walls also feature protruding stone steps (*takilpus*), which are handy for bounding up and down terraces during irrigation days (Figure 8).

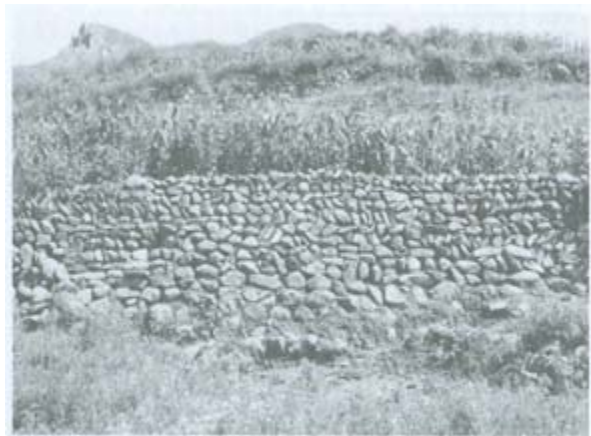
Fig. 6. Reconstructed vertical water channel (*qhalcha*) used to vent water from one terrace to the next.

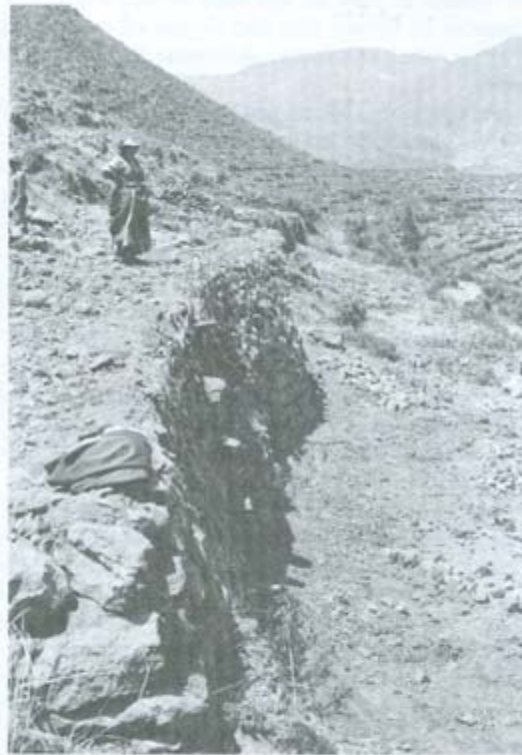
Fig. 8. Finished terrace with *takilpus* in foreground. Note inward inclination of wall for strength.
